Seat Belt Anchorage Test Report

Report Reference No: 1552G

For an In-Vehicle Test
To EC Directive 76/115/EEC
As Amended By 2005/41/EC.
& To ECE Regulation 14.07

Vehicle Type: Ford Transit Custom based Motor Caravan

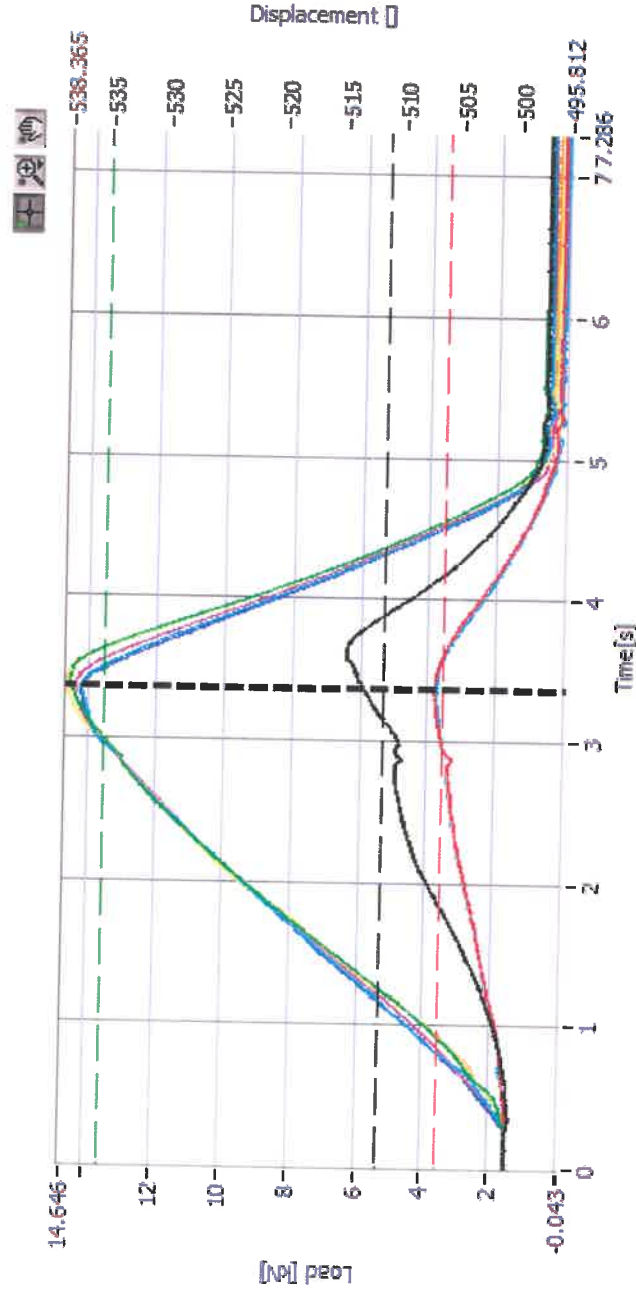
Test Title 1552_4790
 Description Front row
 Date 18/05/2017 10:33:41

Cursor Time (s)	3.367	Target
Load 1	5.91	5.30
Load 2	3.80	3.53
Load 3	14.48	13.50
Load 4	14.17	13.50
Load 5	14.62	13.50
Load 6	14.35	13.50
Load 7	14.58	13.50
Load 8	14.16	13.50
Load 9	0.73	0.00
Load 10	3.71	3.53

The loads held were as shown in the graphs found in Appendix 2:

Seat Vehicle position	LH/C
Upper X displacement	223
X displacement limit	394
Upper Z displacement	99
Z displacement limit	-93
76/115/EC Result	PASS
ECE R14 Result	PASS

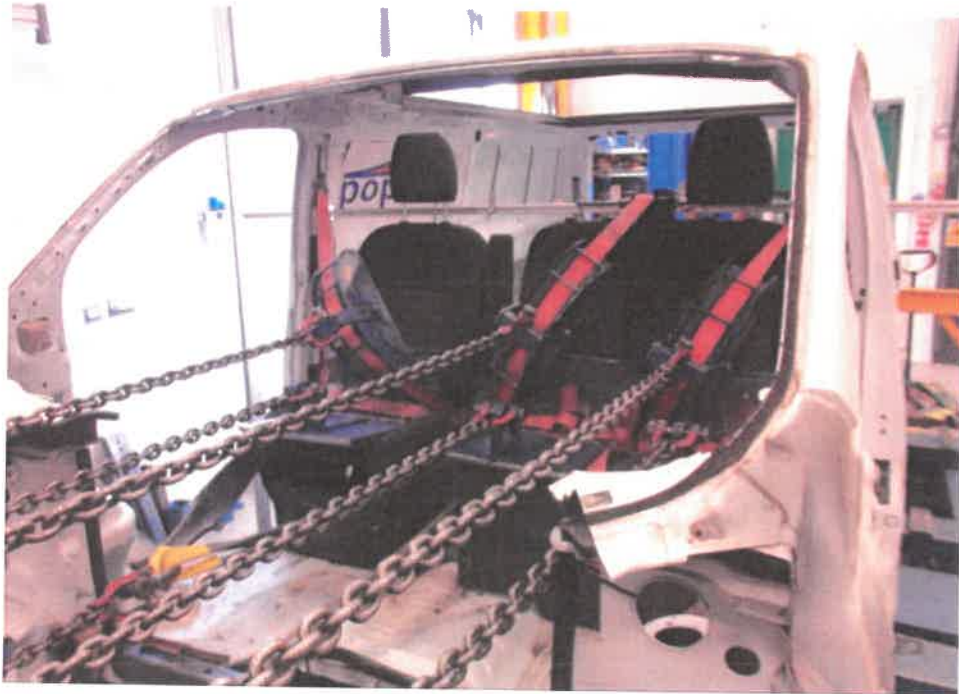
Figure 3.1 – 1552_4790

Driver's seat and double passenger seat.

Seat Vehicle Position		RH	LH/C	LH
Vehicle row		First		
Seat Manufacturer		OE	OE	
Seat name		OE Driver	OE Passenger	
Seat type		Single	Double	
Belt type		3 Point	3 Point	3 Point
Anchorage on seat		All	All	All
Seat weight (kg)		27.00	36.00	
Load applied (kN)	Lap	13.5	13.50	13.50
	Diagonal	13.50	13.50	13.50
	Seat C of G	5.30	3.53	3.53
Load Channel No	Lap	3	5	7
	Diagonal	4	6	8
	Seat C of G	1	2	10

Refer to the pre-test photographs shown in Appendix 3.

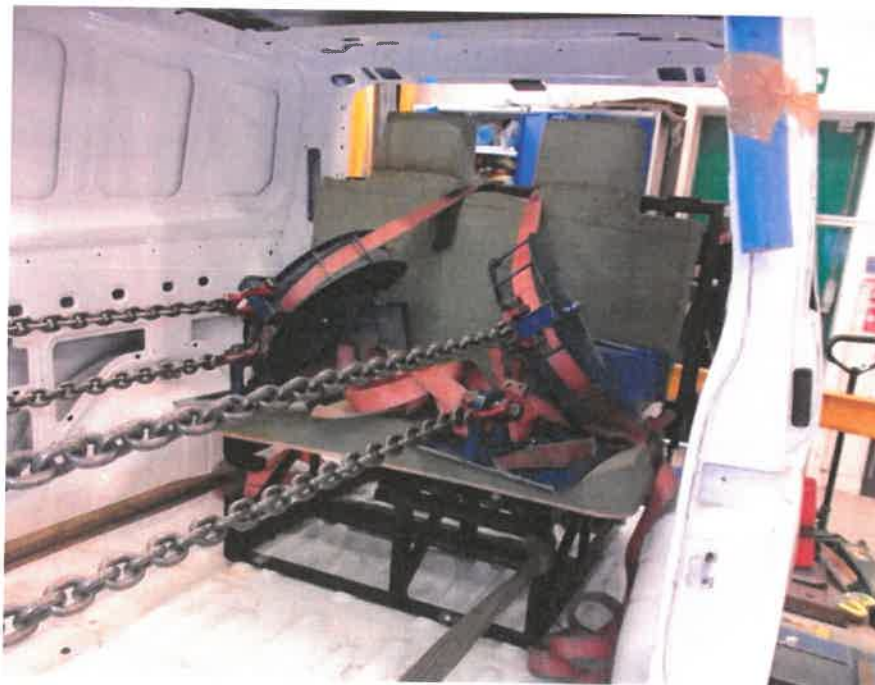
Figure 3.2 – 1552_4791

Nulite NL BD2 Double Seat / Bed.

Seat Vehicle Position		RH	LH
Vehicle row		Rearmost	
Seat Manufacturer		Nulite	
Seat name		NL BD2	
Seat type		Double	
Belt type		3 Point	3 Point
Anchorage on seat		All	All
Seat weight (kg)		95.25	95.25
Load applied (kN)	Lap	13.5	13.50
	Diagonal	13.50	13.50
	Seat C of G	9.34	9.34
Load Channel No	Lap	3	7
	Diagonal	4	8
	Seat C of G	1	10

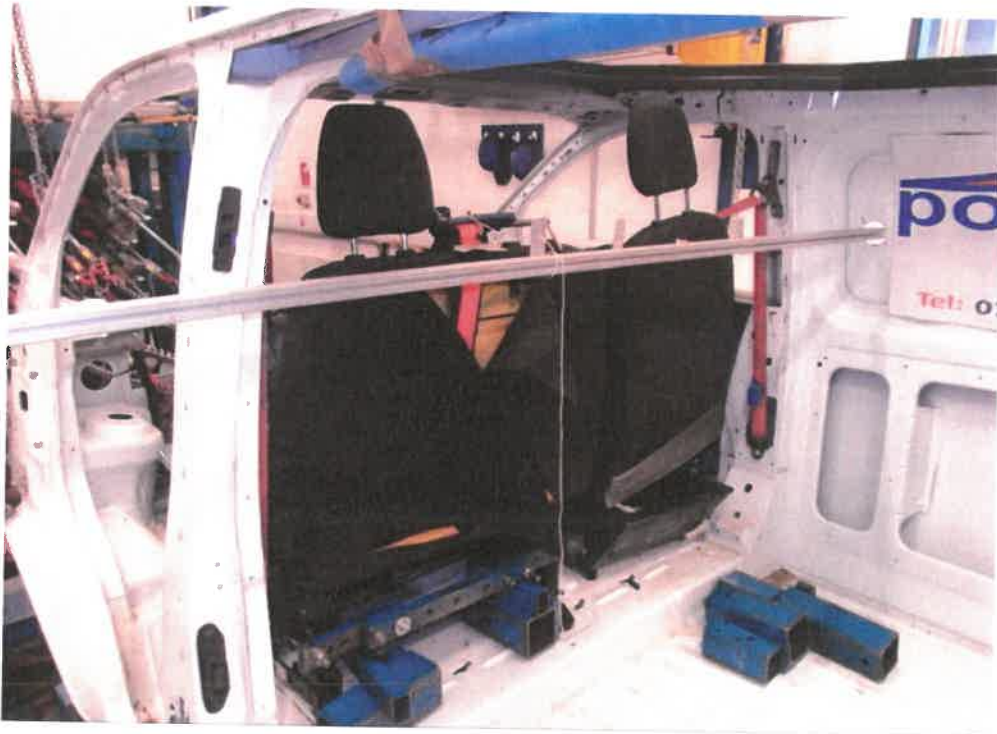
Figure 4.1 – 1552_4790

Test Ref	Observation
1552_4790	Seats generally pulled forwards. Driver's seat separated slightly from base pedestal (rear RHS) as there was no slide bolt present. All loads held. Deformation of floor/step adjacent to LH seat visible.
1552_4791	Rear plate deformed slightly and pulled floor up at rear slightly but not excessively.

See also Post-test photographs are shown in Appendix 4.
