Seat Belt Anchorage Test Report

Report Reference No: 1552E

For an In-Vehicle Test
To EC Directive 76/115/EEC
As Amended By 2005/41/EC.
& To ECE Regulation 14.07

Vehicle Type: Mercedes Vito based Motor Caravan

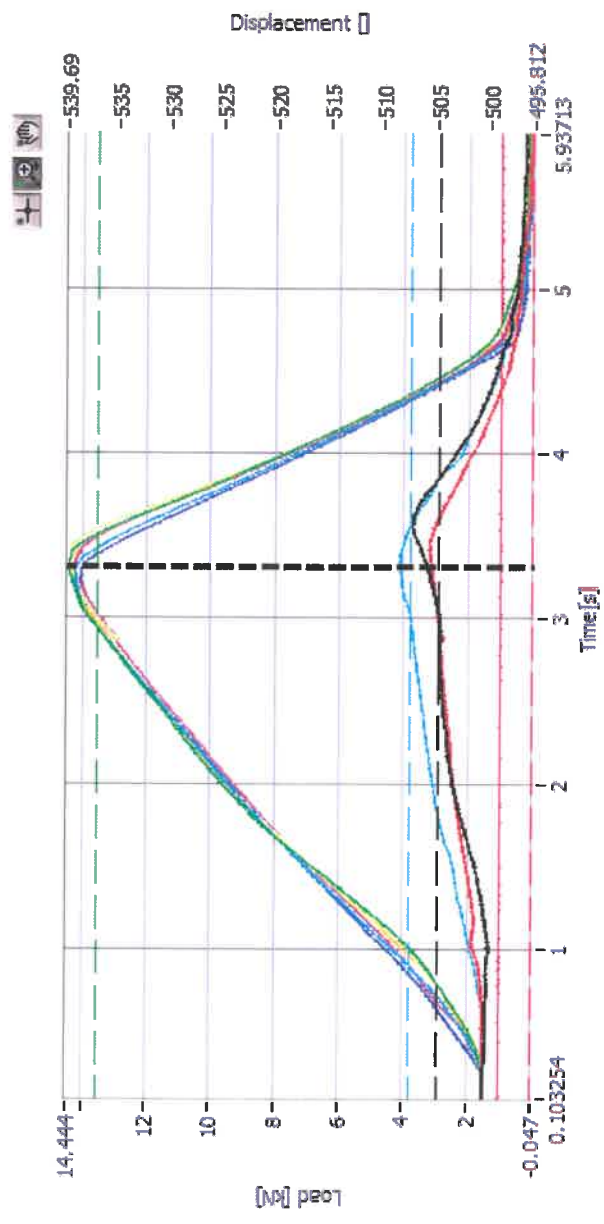
Test Title 1552_4732

Description Frontrow

Overlay	Target Loads	Target	
Load 1		3.27	2.94
Load 2		3.16	2.94
Load 3		14.42	13.50
Load 4		14.22	13.50
Load 5		14.40	13.50
Load 6		14.24	13.50
Load 7		14.32	13.50
Load 8		13.99	13.50
Load 9		1.01	0.00
Load 10		4.10	3.77

The loads held were as shown in the graphs found in Appendix 2:

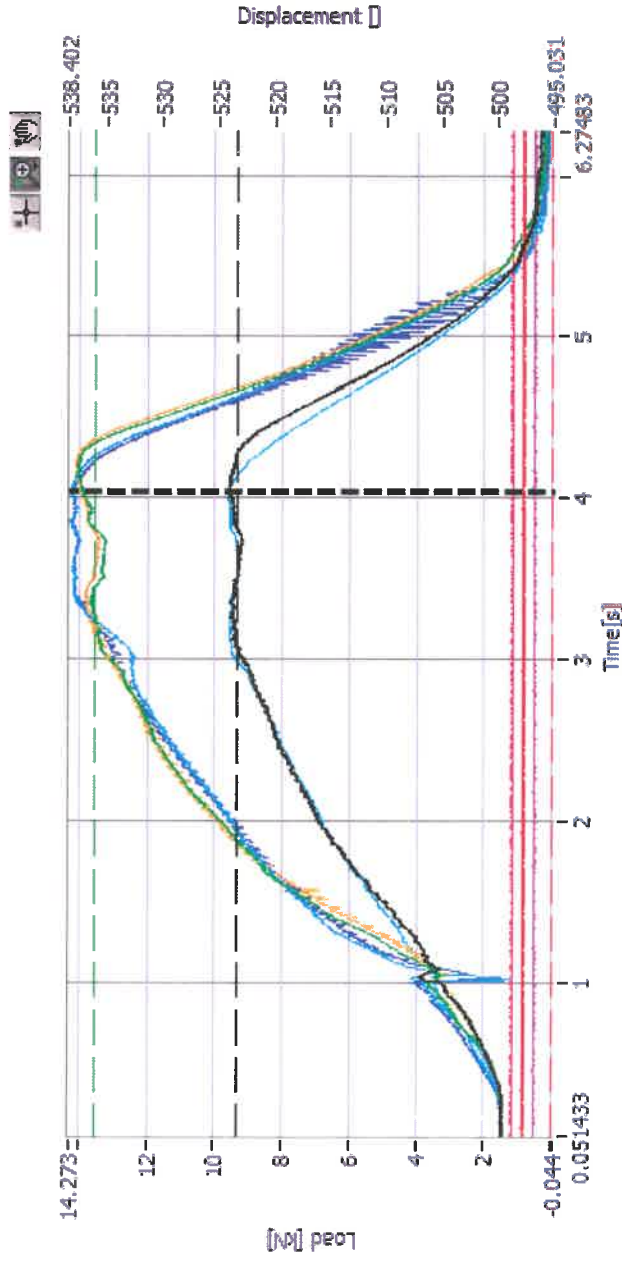
Test Title 1552_4733

Description Rock n roll double

Cursor Time (s)	4.037	Target
Overlay Target Loads		
Load 1	9.52	9.34
Load 2	0.87	0.00
Load 3	13.88	13.50
Load 4	14.18	13.50
Load 5	0.85	0.00
Load 6	0.51	0.00
Load 7	13.93	13.50
Load 8	14.15	13.50
Load 9	1.17	0.00
Load 10	9.62	9.34
