## **Seat Belt Anchorage Test Report**

**Report Reference No: 1552F**

For an In-Vehicle Test  
To EC Directive 76/115/EEC  
As Amended By 2005/41/EC.  
& To ECE Regulation 14.07

**Vehicle Type:** Renault Trafic / Vauxhall Vivaro / Opel Vivaro / Nissan NV300 /  
Nissan Primastar / Fiat Talento based Motor Caravan

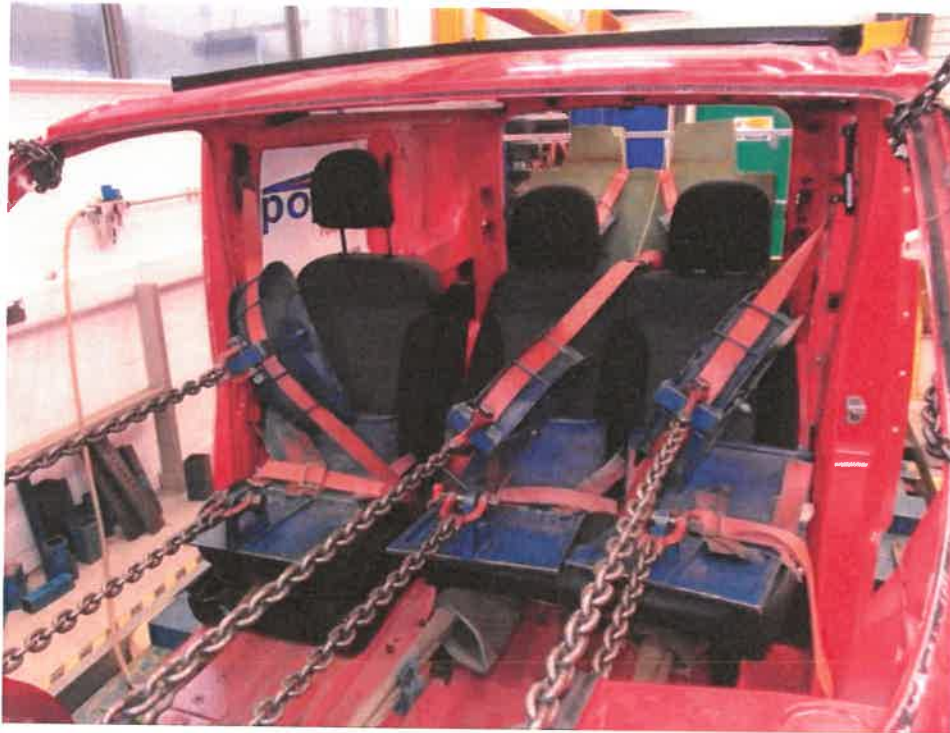
**Figure 3.1 – 1552\_4771**

Driver's seat and double passenger seat.

Refer to the pre-test photographs shown in Appendix 3.

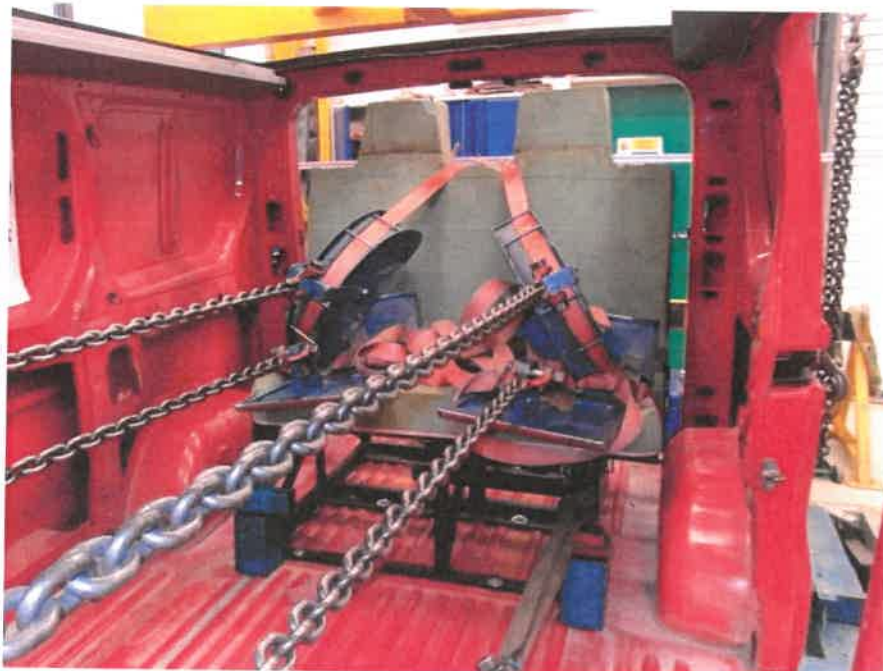
**Figure 3.2 – 1552\_4772**

Nulite NL BD2 Double Seat / Bed.

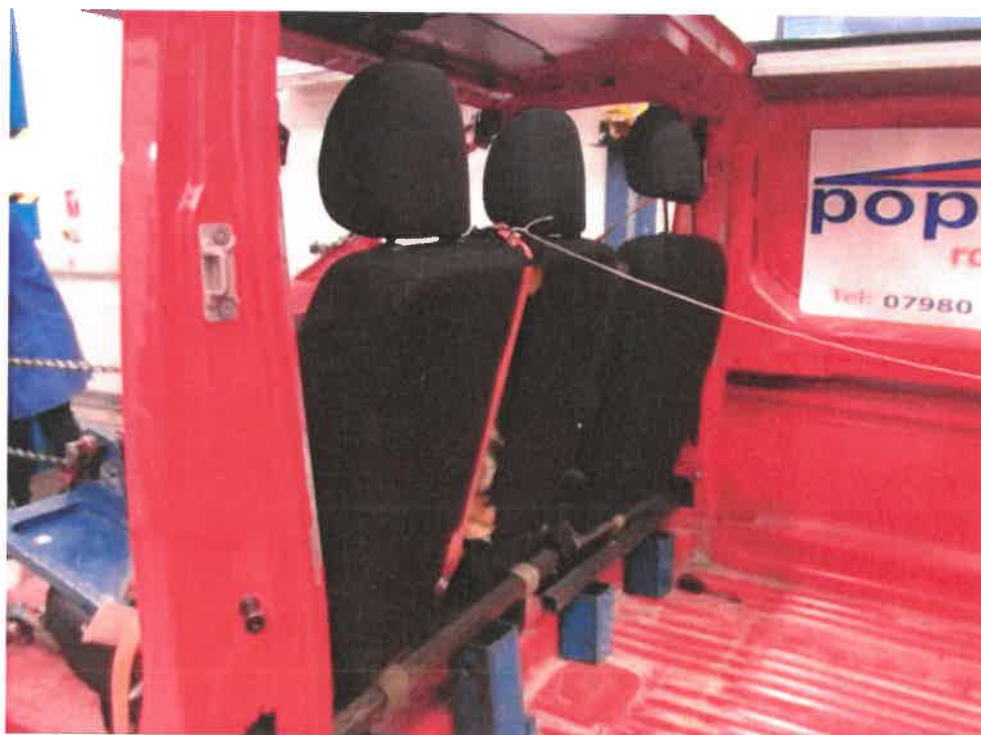
**Figure 4.1 – 1552\_4771**

Test Ref	Observation
1552_4771	Left hand upper adjuster bent slightly otherwise minimal deformation.
1552_4772	Little Visible deformation.

See also Post-test photographs are shown in Appendix 4.
